Air Accidents Investigation Branch

**Report on the accident to
Boeing 777-222, registration N786UA
at London Heathrow Airport
on 26 February 2007**

A preliminary report on the initial findings from the accident was published in AAIB Special Bulletin S2-2007 on 17 April 2007. This formal report contains the final findings and Safety Recommendations from the investigation.

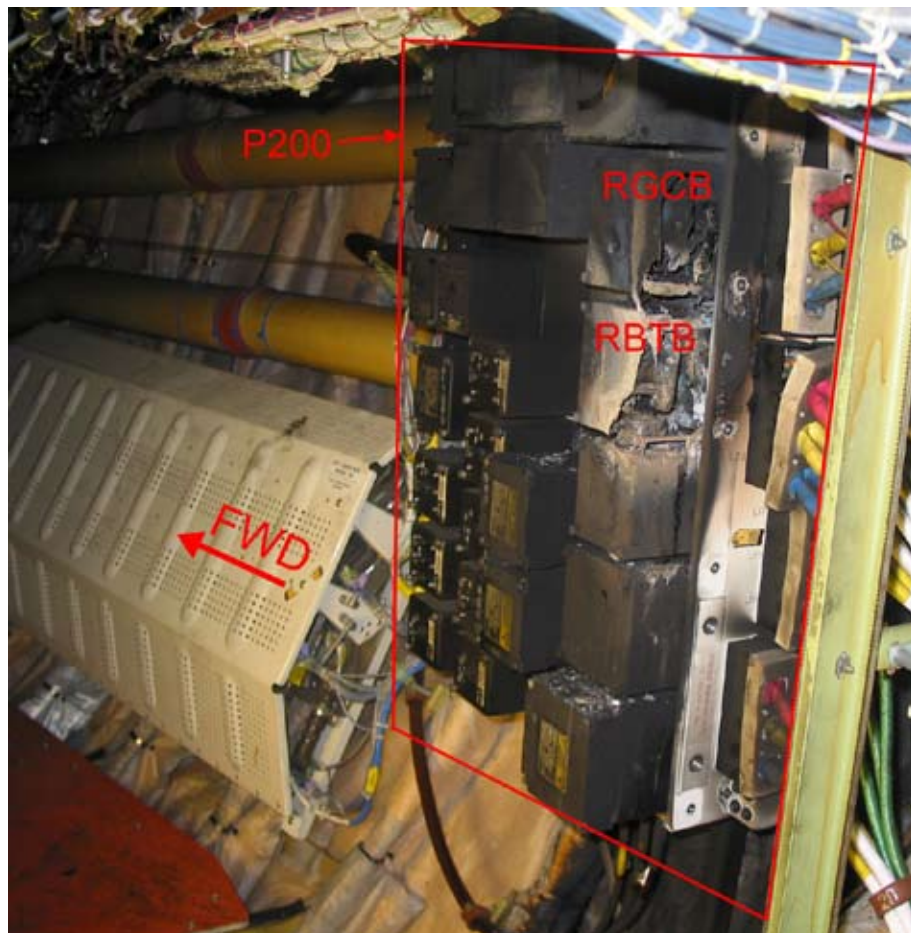
Figure 2

An inspection inside the MEC after the accident revealed extensive heat and fire damage to the P200 power panel which is located to the right of the nose gear wheel well (see Figure 1). The worst affected components of the power panel were the Right Generator Circuit Breaker (RGCB) and Right Bus Tie Breaker (RBTB) contactors, parts of which had melted and vaporised (see Figure 2). There was evidence that molten metal had dripped down onto the insulation blankets beneath the power panel. There was extensive fire damage to the fire-retardant insulation blankets located behind the power panel and beneath the panel under the floor, as shown in Figure 3. Nearby components including a floor panel, equipment cooling system ducting, other wire bundles and some structural frames and stringers in the vicinity were later determined to have suffered sufficient heat damage to require replacement. A more detailed description of the aircraft damage is included in section 1.12.

Fire damage to P200 power panel (cover removed), showing burnt-out RGCB and RBTB contactors (viewed looking forward and to the right)

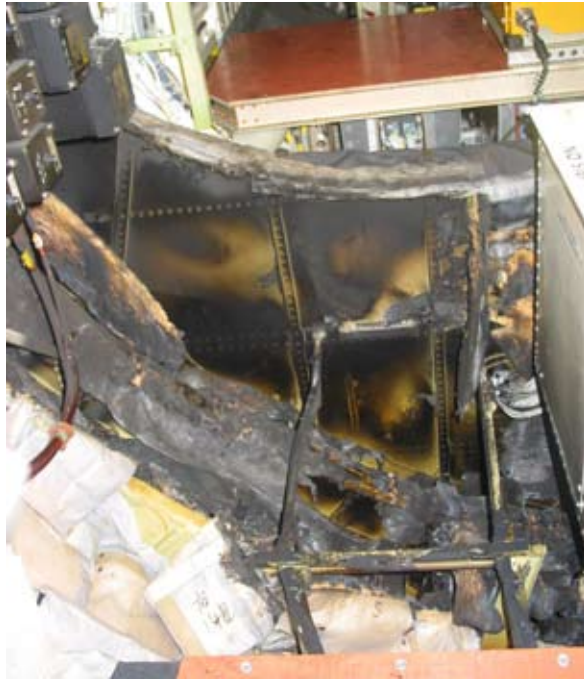
Figure 3

Burnt aircraft structure and insulation blankets located directly below P200 power panel (viewed looking down and aft; the floor panel has been removed)

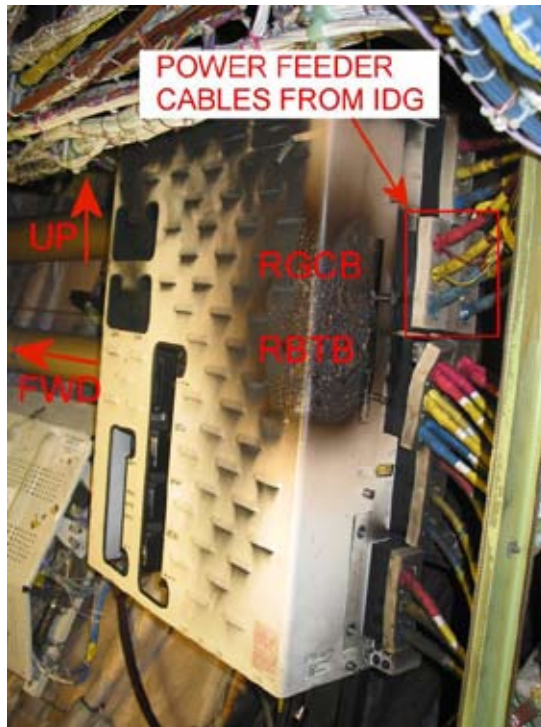
Figure 16

The insulation blankets behind, below and opposite the P200 power panel had suffered significant fire damage and some sections had charred to ash. Sections of the P200 power panel cover were coated in soot and the area covering the RGCB and RBTB exhibited blistering associated with heat damage (see Figure 16). The power cables connected to the P200 power panel were sooted and some exhibited minor heat damage of the coloured insulation sleeves, but none were damaged. The torque of the nuts connecting the power cables was measured and found to be satisfactory.

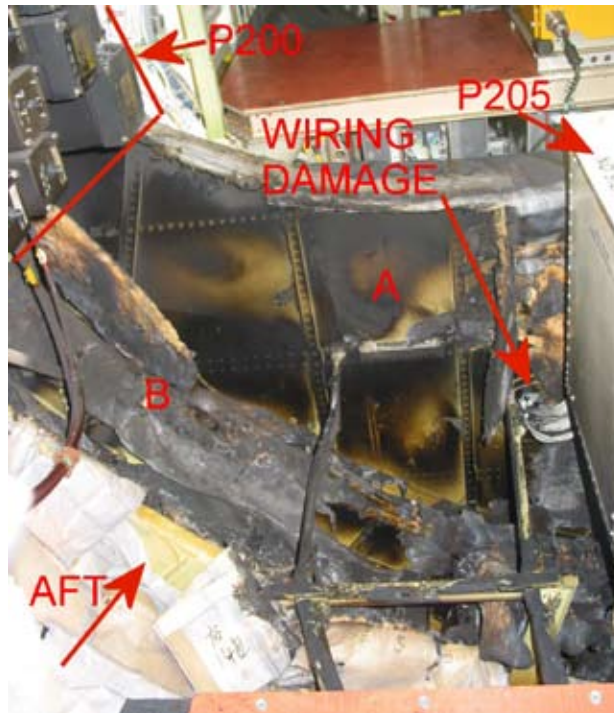
Figure 17

The most extensive insulation blanket fire damage was directly below the P200 power panel as depicted in Figure 17. In this figure the P200 power panel cover has been removed and the floor panel which abuts against frame 'A' has also been removed. A wire bundle from the P205 panel, also shown in Figure 17, had some heat damage and possibly fire damage.

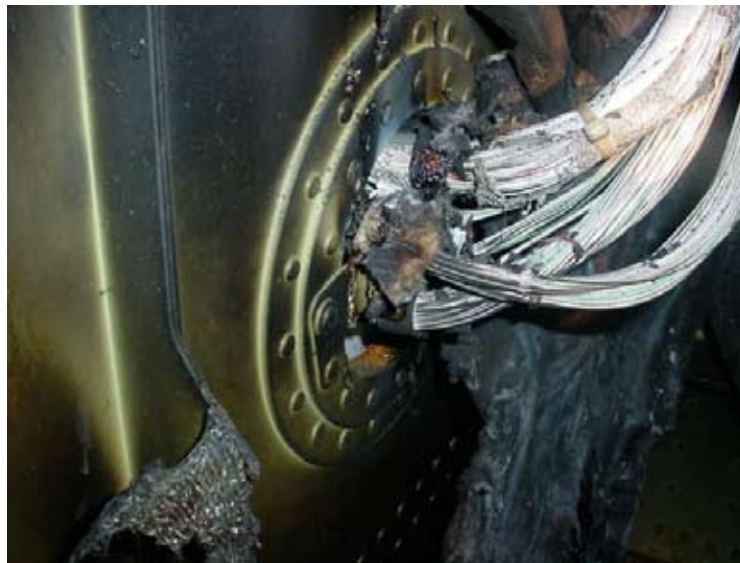
Figure 18

A number of wire bundles from the P205 panel had suffered heat damage where they passed through a hole in the bulkhead aft of the panel. This is the area labelled as ‘Wiring Damage’ in Figure 17 and a close-up of this damage is shown in Figure 18. A number of these wires had insulation heat damage and were coated in soot. Some wire ties had burnt and bundle clamps had melted. A close examination of the wires at the bulkhead did not reveal any which had suffered sufficient insulation damage to expose the conductive wiring. However, a few wires higher up in the bundle, which were in direct physical contact with an insulation blanket, had insulation that had completely burnt away, exposing its conductive wiring. Some faults detected on the FDR were consistent with wire damage from the P205 panel (see section 1.11.5, page 26), although no associated circuit breakers had been tripped.

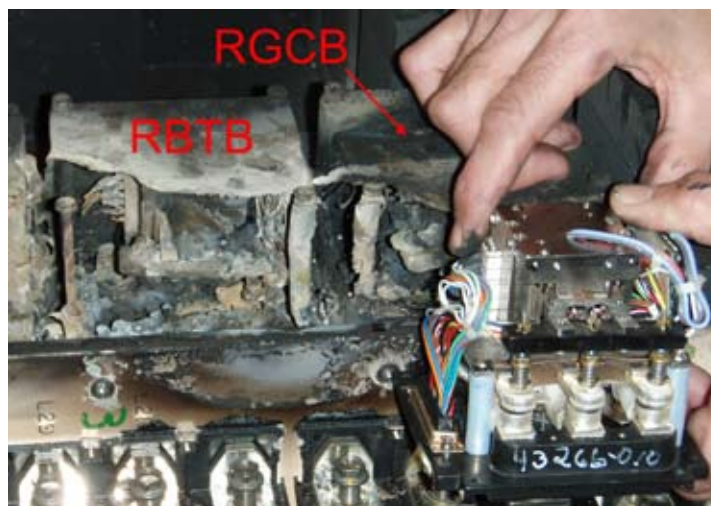
Figure 26

The RGCB and RBTB contactors formed the focus of this accident investigation. The extent of the damage to the RBTB and RGCB can be seen in Figure 26, where they are compared to a new contactor. The damage to the GSR, located directly below the RBTB, appeared to have been caused by molten material dropping down from the contactors above and therefore was not the subject of detailed examination.

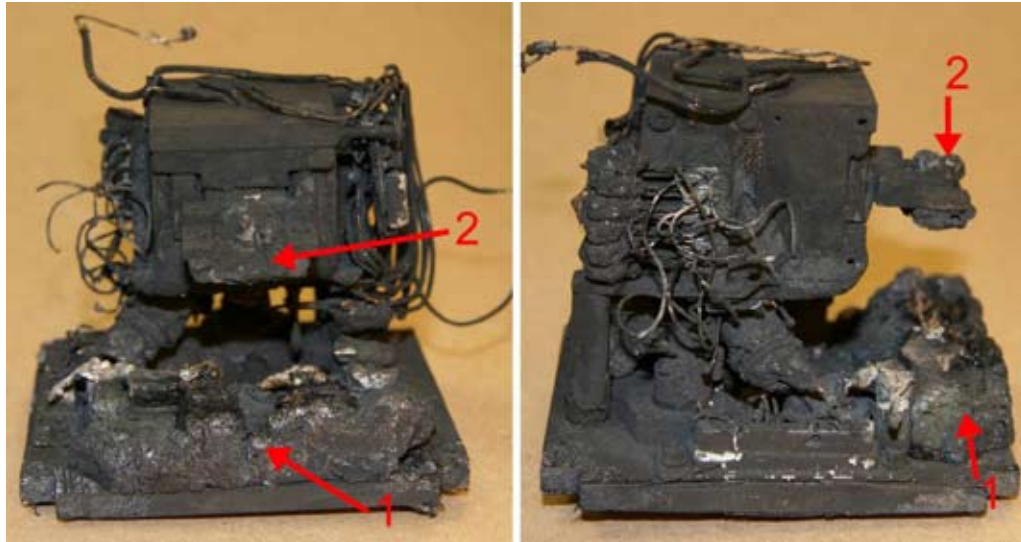
Figure 27

The RGCB was more intact than the RBTB and is shown in Figure 27. The movable contact support bar was found in the 'contactor closed' position and this was considered to be a reliable indication of the contactor's final state. The position of the auxiliary contacts could not be determined because heat had damaged the auxiliary contact actuation blocks which allowed all the contacts, in this case, to relax into an open state. All auxiliary contact blades were intact and accounted for.

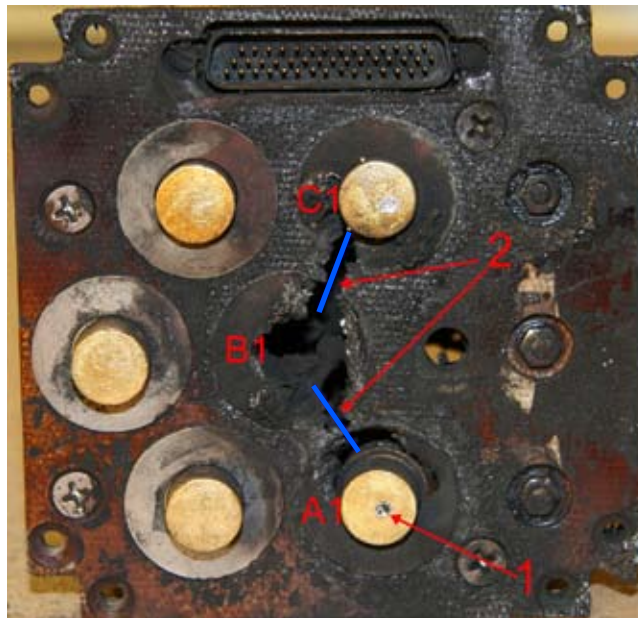
Figure 28

The external base of the RGCB revealed evidence of a severe arc or short-circuit between the A1 and B1 phase plungers and between the C1 and B1 phase plungers (see Figure 28). The B1 phase plunger had melted or vaporised.

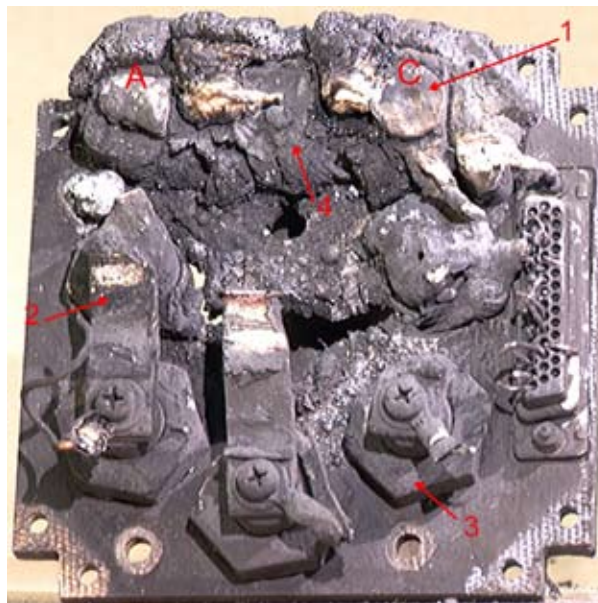
Figure 29

The internal base plate of the RGCB revealed that part of stationary contact C was still intact (see item 1 in Figure 29), but it had a deep arc pit at its centre. Stationary contact A had melted. The Teflon arc chute had mostly melted or vaporised, but its two retaining screws were in place. The charred remains of the stationary contact support block were consistent with the melamine material used on the early contactors. Most of the silver pigtail foils had burnt away and three of the six plunger nuts had melted or vaporised; these were the three connected to the stationary contacts. The overall severity of the damage made it impossible to determine the initiating point of the failure, but the damage was consistent with a high degree of heat generated from multiple arcs and short-circuits. The most severe of these arcs were in the area of the main contacts and between the plungers and plunger nuts connected to the stationary contacts.

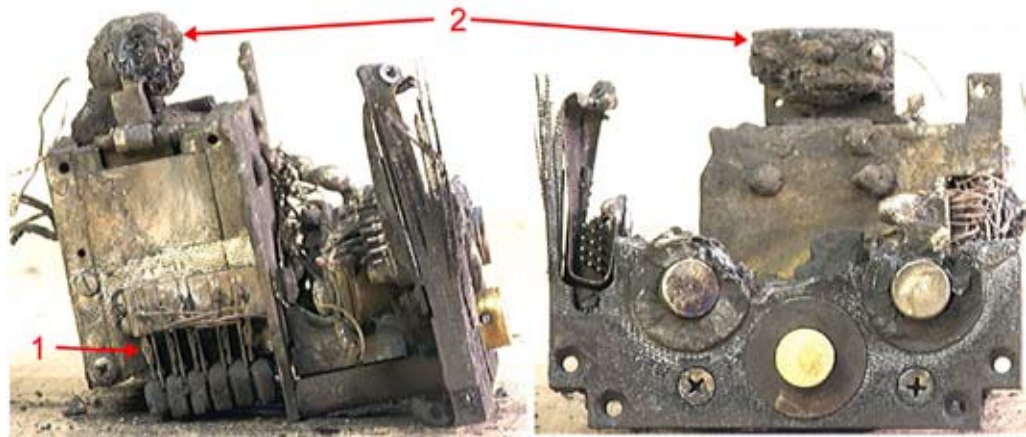
Figure 30

The RBTB had suffered significantly more damage than the RGCB and therefore there were fewer remains to examine (see Figure 30). The RBTB's movable contact support bar was found in the 'contactor open' position. The position of the auxiliary contacts could not be determined because heat had damaged the auxiliary contact actuation blocks. All auxiliary contact blades were intact and accounted for.

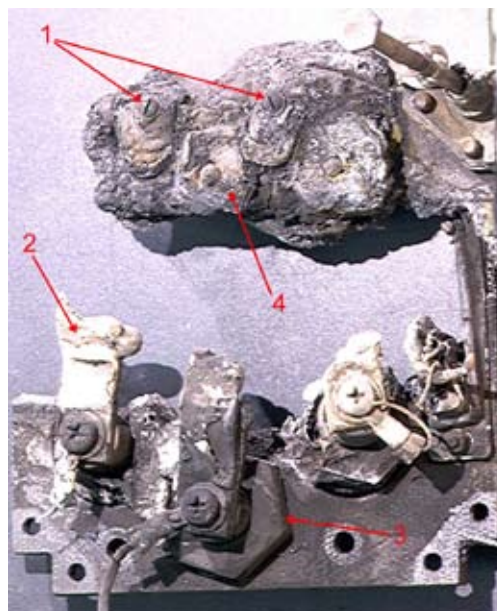
Figure 31

Only the three plungers connected to the movable contacts were still in place – the remains of the other three plungers were welded to the power panel. None of the stationary or movable contacts remained in the RBTB – all had melted or vaporised. Remains of the charred contact support block, consistent with melamine material, were visible. The arc chute had melted or vaporised, but its two retaining screws were found in place (see Figure 31). Most of the silver pigtail foils had burnt away.

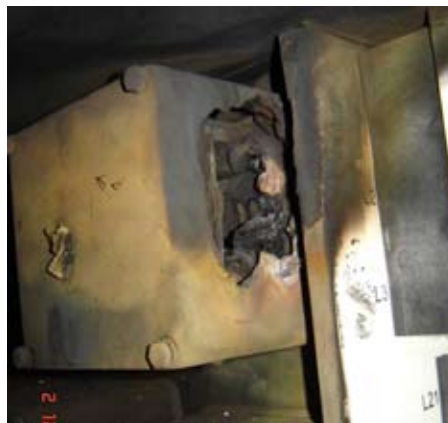
Figure 36

In August 2006 a Boeing 777-300ER, registration A6-EBF, suffered damage to its P300 power panel and major damage to its APB contactor. The aircraft had landed and after engine shutdown the APU generator did not come online. The APU generator switch was cycled and the power came on. The aircraft was parked and the electrical power shut down. A few hours later a mechanic noticed a burning smell. When he applied electrical power to the aircraft he heard a loud bang. An inspection revealed a large burnt hole in the side of the

APB – see Figure 36. The aircraft manufacturer determined the direct cause to be an internal failure of the contactor, although the specific internal failure and root cause were not identified (see section 1.16.4 for further detail on the contactor examination).

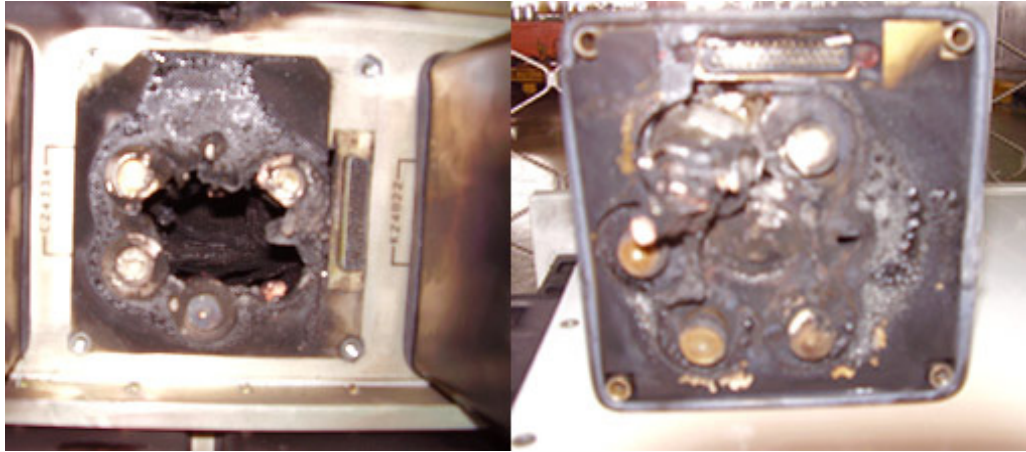
Figure 37

Damaged RBTB mating point (left) and RBTB (right) from incident in November 2006 on aircraft 9V-SYK

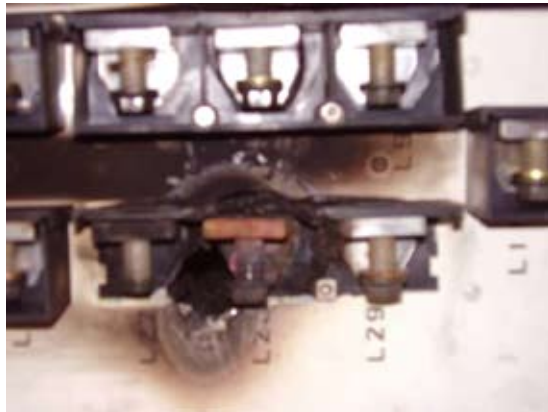
Figure 38

of the failure was due to a loose terminal lug, due to a manufacturing defect or thermal cycling. A photo of the overheated terminal lug is shown in Figure 38. The terminal lugs on N786UA had not suffered from significant overheating.

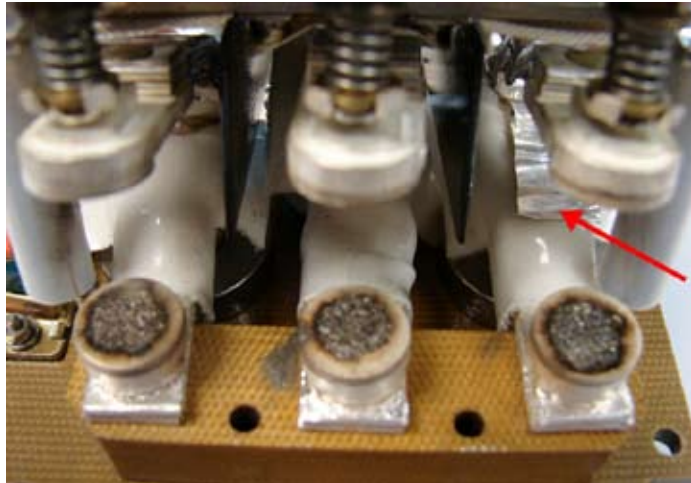
Figure 41

- 3) Six contactors were found to have broken silver pigtail foils. In these contactors a single foil had separated from its attachment point to a movable main contact (see example in Figure 41). In the cases where the foil had broken free from the lower side of a movable contact, the foil had dropped down onto the insulation of the lower pigtail foil. Tests were carried out to examine the effects of a short-circuit via a single pigtail foil. The tests revealed that when shorted a portion of the pigtail foil vaporised instantly (acting like a fuse), which generated an air gap and prevented further damage.

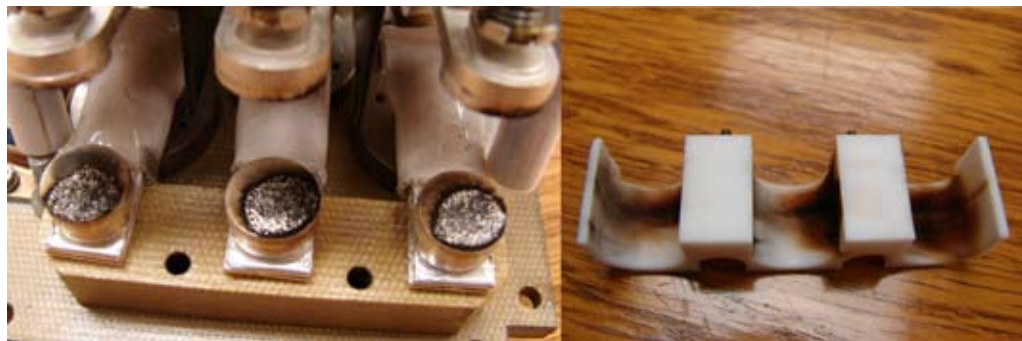
Figure 43

The remaining over-travel gap (defined in section 1.6.7, page 17) is a measure of the depth of contact erosion. This gap is factory set to be between 0.018 and 0.032 inches. The high-time/high-cycle contactors averaged over-travel gaps of around 0.014 inches (meaning erosion of between 0.004 and 0.018 inches), although a minimum gap of 0.002 inches was measured on two contactors.

Example of a contactor with high main contact erosion (left) and dark arc chute deposits (right); this is an RBTB which has completed 45,700 flying hours and 14,500 flight cycles)

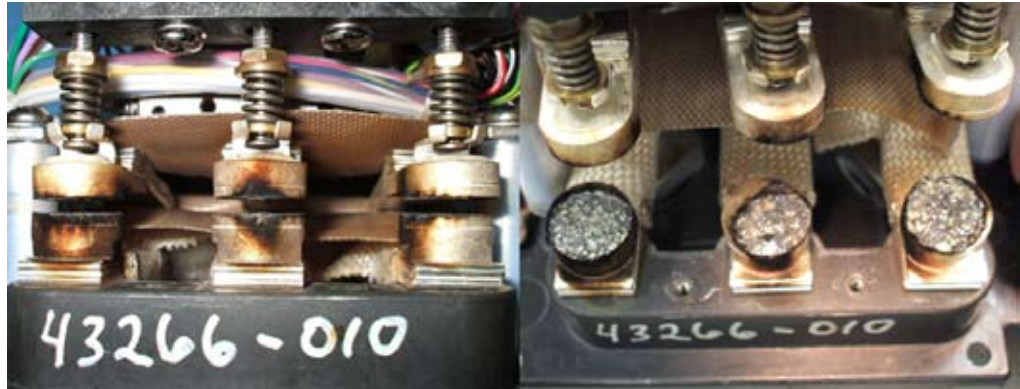
Figure 47

Towards the end of the test the B phase contact mating point had migrated to near the front edge of the contact causing material splatter to create a ragged edge on the contact, but the temperature was not increasing. The contactor continued to operate without failure up to the 50,000 cycle test limit. The condition of the main contacts at the end of this test is shown in Figure 47.
