Air Accidents Investigation Branch

**Report on the accident to
Boeing 777-222, registration N786UA
at London Heathrow Airport
on 26 February 2007**

A preliminary report on the initial findings from the accident was published in AAIB Special Bulletin S2-2007 on 17 April 2007. This formal report contains the final findings and Safety Recommendations from the investigation.

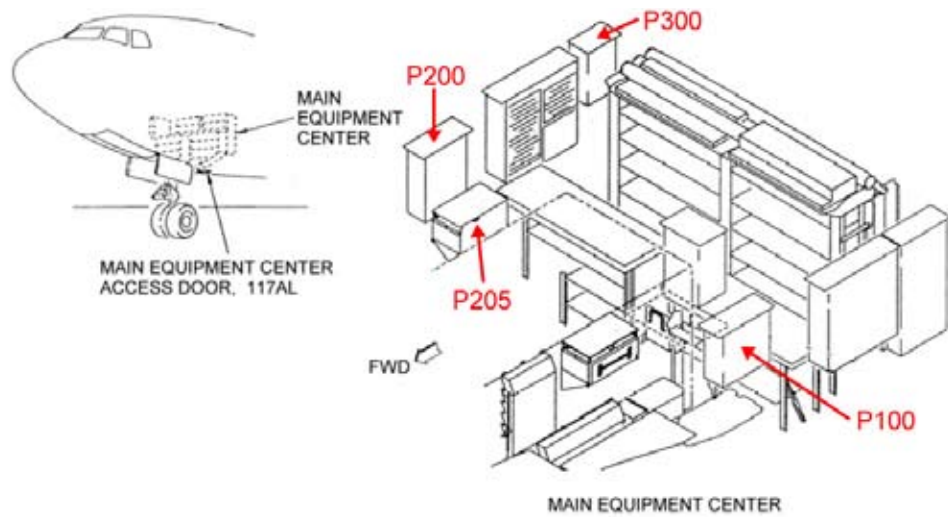
Figure 1

An inspection inside the MEC after the accident revealed extensive heat and fire damage to the P200 power panel which is located to the right of the nose gear wheel well (see Figure 1). The worst affected components of the power panel were the Right Generator Circuit Breaker (RGCB) and Right Bus Tie Breaker (RBTB) contactors, parts of which had melted and vaporised (see Figure 2). There was evidence that molten metal had dripped down onto the insulation blankets beneath the power panel. There was extensive fire damage to the fire-retardant insulation blankets located behind the power panel and beneath the panel under the floor, as shown in Figure 3. Nearby components including a floor panel, equipment cooling system ducting, other wire bundles and some structural frames and stringers in the vicinity were later determined to have suffered sufficient heat damage to require replacement. A more detailed description of the aircraft damage is included in section 1.12.

Location of P200 power panel and nearby panels in the MEC

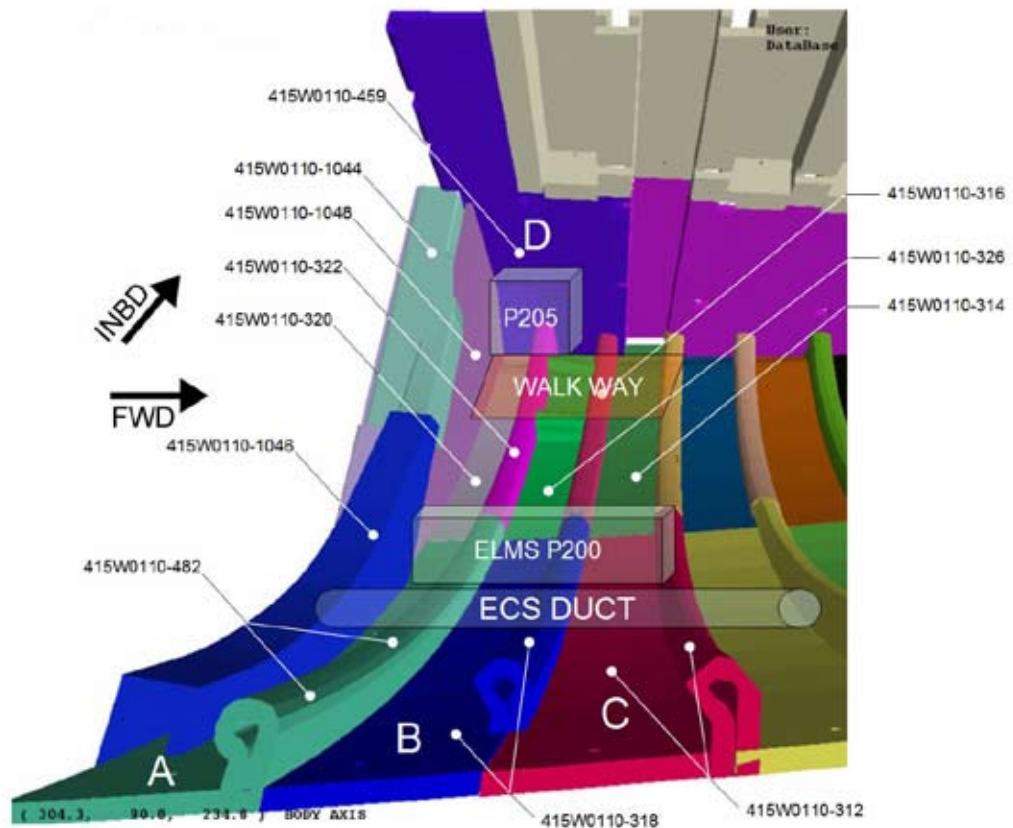
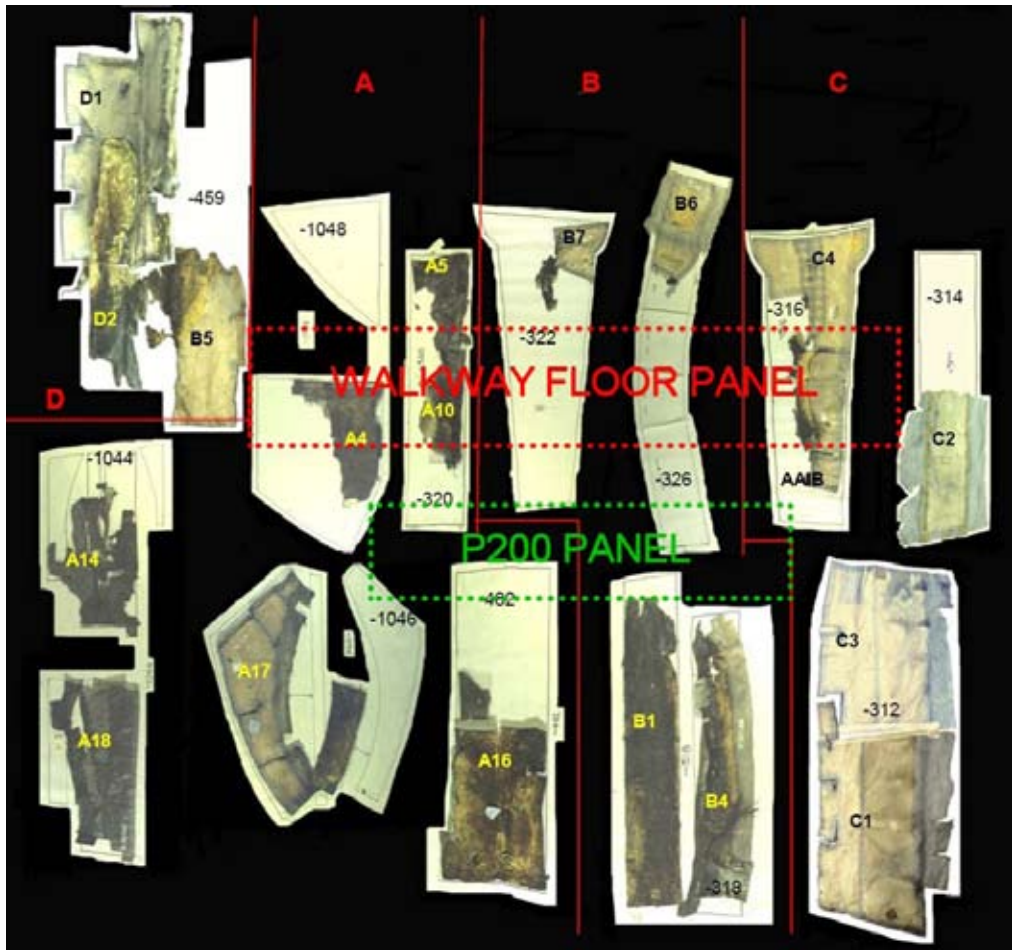
The insulation blankets around the P200 panel area were removed from the aircraft and sent to the U.S. National Transportation Safety Board (NTSB) where their fire investigators conducted an initial visual examination. The insulation blankets were then sent to the aircraft manufacturer for a detailed examination in their materials laboratory. A top view schematic of the insulation layout in the aircraft is shown in Figure 19. The insulation blankets were identified using a combination of visible part numbers, comparisons to drawings, and comparison to photographs taken on the aircraft. A composite photograph of the identified insulation blankets is shown in Figure 20. The blank areas are areas where the insulation was either completely burned, too charred to identify, or missing.

Top view schematic (looking down on to top of P200 panel) showing layout of insulation materials sections A, B, C and D (walkway floor panel, P200, P205 and ECS duct are not drawn to scale)

Composite photograph showing all the insulation blankets that were recovered and examined by the aircraft manufacturer. The blankets are laid out in sections A, B, C and D corresponding to Figure 19

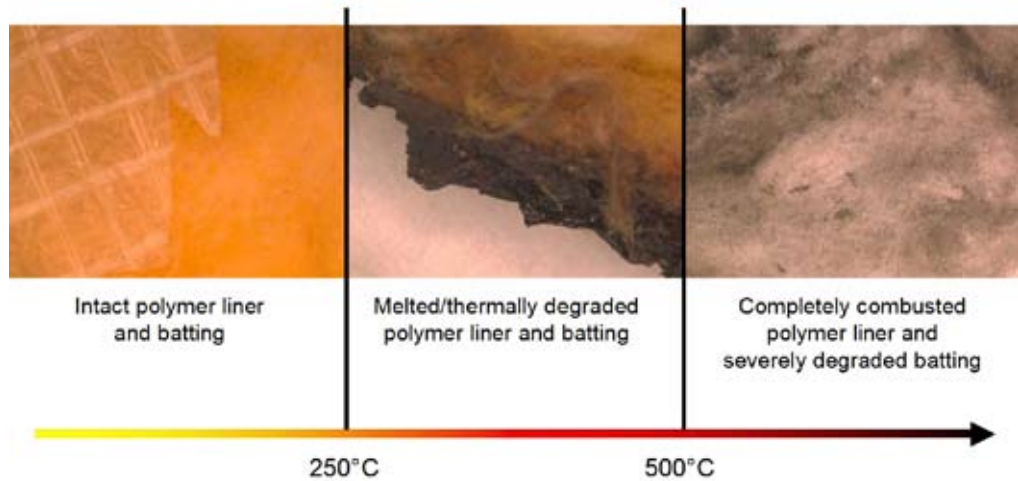
Figure 21

The identifiable part numbers on the insulation blankets revealed that they were of ‘Original Equipment Manufacture’ (OEM) which meant that they were the type of blanket that would have been originally installed during manufacture of the aircraft. The insulation that was the most charred was in the area directly below and behind the P200 power panel. The known thermal properties of the insulation materials were used to determine the approximate temperature that sections of insulation material had been exposed to. A specimen was estimated to have reached a temperature of 250°C if its polymer liner had melted and its underlying fibreglass batting was still intact. A specimen was estimated to have reached a temperature greater than 500°C if the resin in the batting was completely burned leaving only glass fibres (see example photos in Figure 21).

Estimated exposure temperature range as a function of insulation degradation

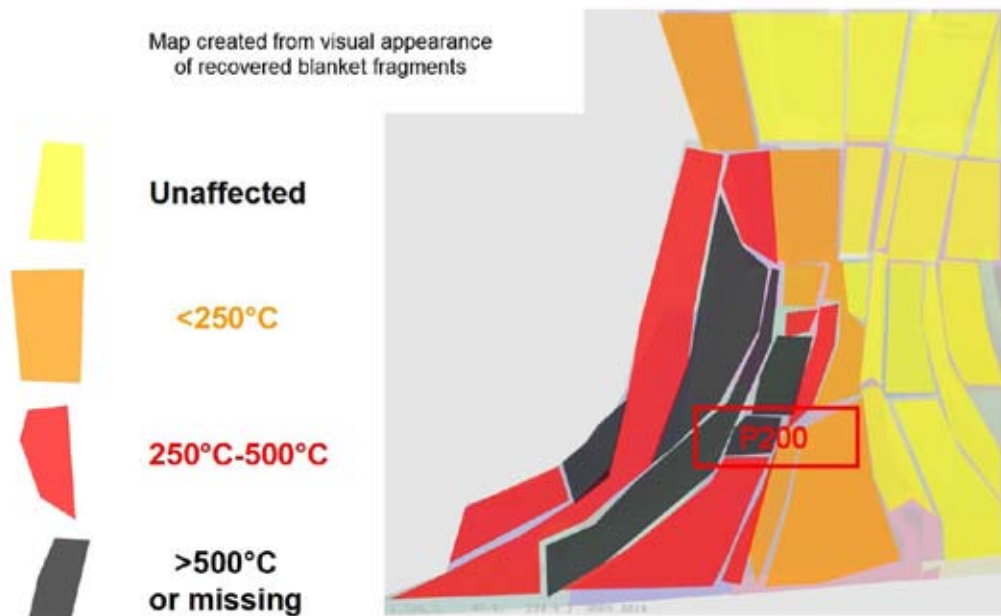
Figure 22

Once each section of insulation material was categorized a map was created to depict the estimated temperatures attained in relation to the location of the P200 power panel (see Figure 22). This map was produced using visual appearance only and is, at best, a rough estimate of the actual temperatures experienced during the event.

Top view of P200 panel showing estimated exposure temperature of surrounding insulation material

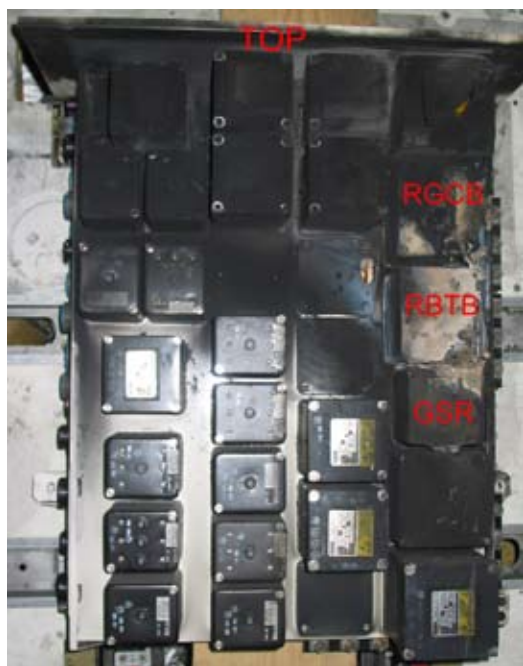
Figure 23

The P200 power panel, part number P-200-2002 and serial number TA-11993, was examined in situ and then removed from the aircraft for a detailed examination at the power panel manufacturer in the U.K. The front and rear of the panel are shown in Figures 23 and 24.

Front of P200 power panel showing locations of RGCB, RBTB and GSR

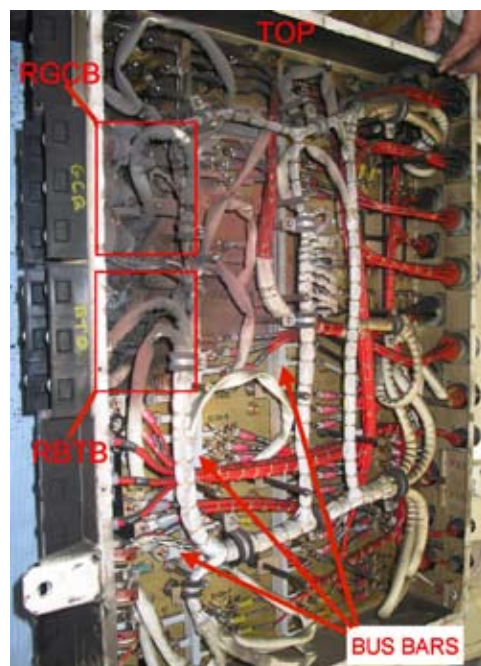
Figure 24

Rear of P200 power panel showing the bus bars, control wiring and the areas on the opposite side of the RGCB and RBTB

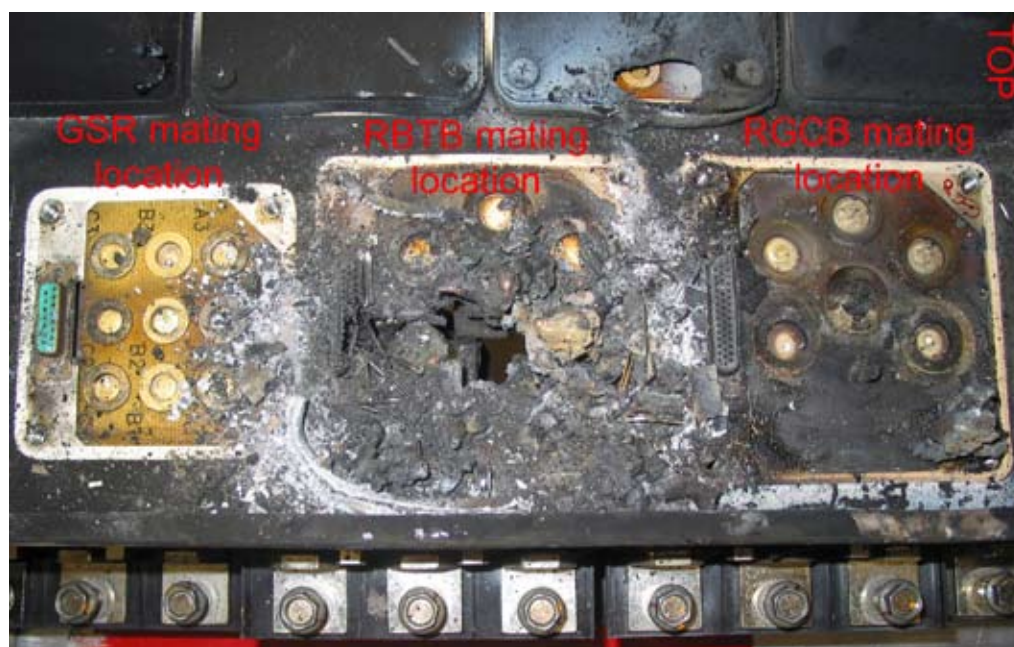
Figure 25

The RGCB was removed from the panel which revealed that its mating location (see Figure 25) had remains of one of the RGCBs plungers on its lower centre (B1 phase) mating point.

The RBTB was more difficult to remove than the RGCB, as significant parts of it had welded to its mating location (see Figure 25). The RBTB's plunger assemblies from the A1, B1 and C1 phases had all welded to the panel. There was a hole in the melamine backplane material between the B1 and C1 plungers.

Close-up of front of P200 panel with GSR, RBTB and RGCB contactors removed

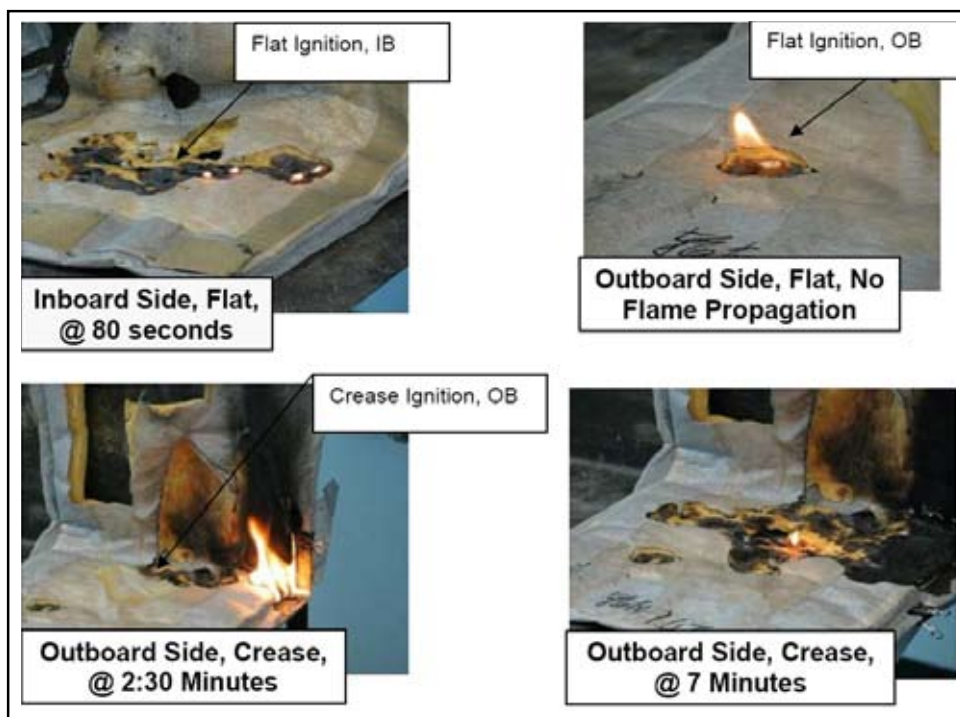
Figure 33

In the tests where the cotton swab was placed on a flat surface the burn length did not exceed 1 inch. However, when the swab was placed in the crease of a folded insulation sample the burn length extended further. Two samples had burn lengths of 9 inches and one sample had a burn length of 9.5 inches – all in excess of the 8 inch maximum requirement. The full results of the tests are included in a table in Appendix E. The aircraft manufacturer noted that the samples did not meet the size configuration of the BSS7357 test standard due to limitations of the available material, and the samples contained stitching thread and taped edges which would not normally be used as test samples and would increase burn length. The photographs in Figures 33 and 34 provide an idea of the fire spread during the cotton swab tests.

Cotton swab flame propagation test of sample 415W0110-314

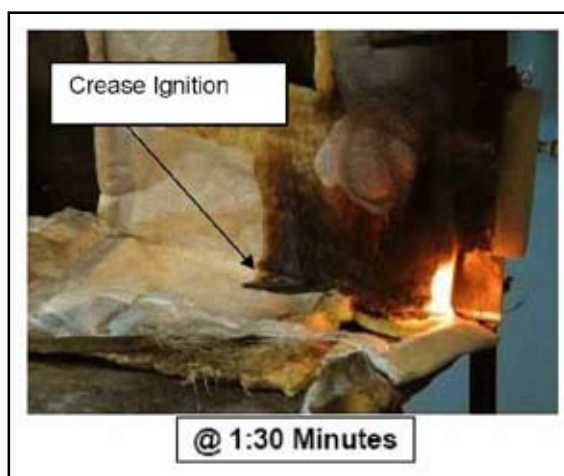
Figure 34

Cotton swab flame propagation test of sample 415W0110-459

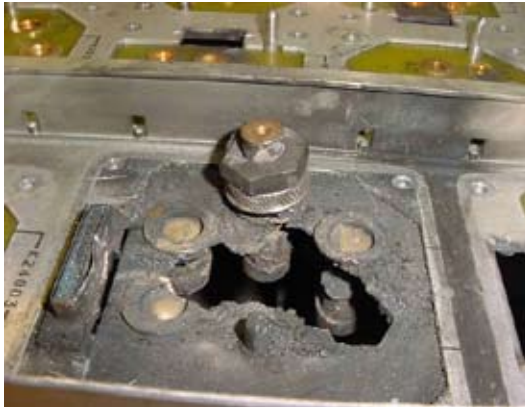
Figure 35

In May 2006 a Boeing 777-200ER, registration PH-BQD, suffered major damage to its P200 power panel and PEPC during ground operations (see Figure 35). It occurred while primary external power was being applied to the aircraft. Mechanics noticed a burning smell and then removed the power. There was extensive damage to the P200 bus bars, including molten metal, and the PEPC was found welded to the panel. The movable contacts and the phase A and phase B pigtail foils inside the PEPC were destroyed. The aircraft manufacturer determined that the cause of the failure was due to a manufacturing defect of the bus to terminal lug connection; this became loose resulting in excessive heat build-up which damaged the bus bar and contactor.

PEPC mating point from incident in May 2006 on aircraft PH-BQD

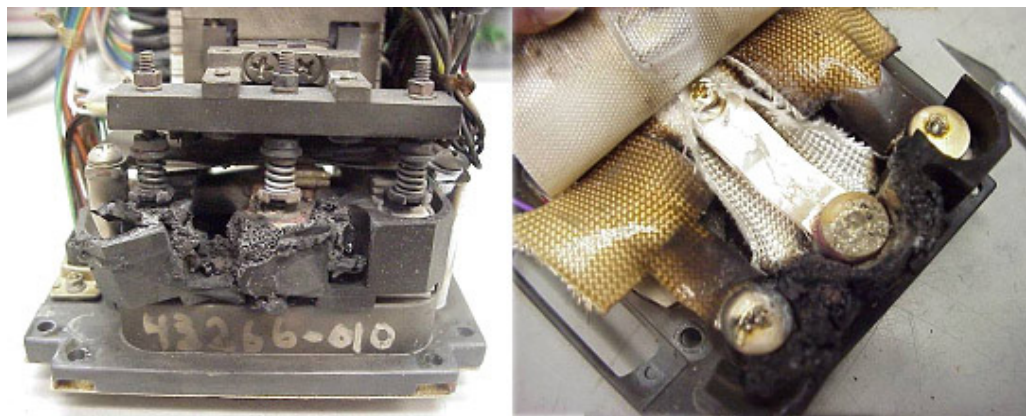
Figure 39

Of the four events involving moderate damage, the cause of three of them was attributed to the contactor. In December 2004 the APU electrical power would not come online on a Boeing 777-200ER, registration 9V-SVO. The APB and its backplane mating point were found to have overheating damage. The damage to the APB's arc chute is shown in Figure 39.

The source of heat in this contactor was attributed to a high resistance at the rivet junction of the phase B movable main contact. It was, however, not clear whether this was caused by a faulty rivet junction or whether heat build-up in the contactor caused the junction to loosen.

Overheating damage and arc damage of the Zytel arc chute from incident in December 2004 on aircraft 9V-SVO

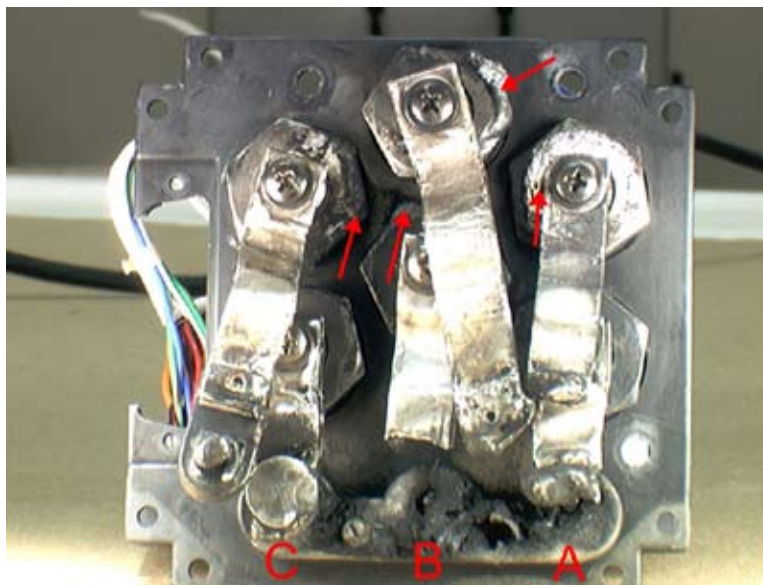
Figure 40

The failed APB contactor from the incident in August 2006 on aircraft A6-EBF underwent a detailed examination at the aircraft manufacturer's EQA laboratory. This contactor suffered significant arcing damage between the phase A and phase B main contacts – see Figure 40.

The phase A and phase B stationary and movable contacts had been completely vaporised by the arcing between them. There was also evidence of arcing between the plunger nuts; this probably occurred as a result of a rapid build-up of ionised arc plasma due to the short-circuiting between the A and B phases. This contactor revealed damage that could have been a precursor to the contactor failures on N786UA. However, no evidence was found that explained the cause of the initial arcing event.

APB contactor base plate from aircraft A6-EBF. Severe arc tracking between phase A and B main contacts. Arrows indicate where arcing occurred across plunger cap nuts.

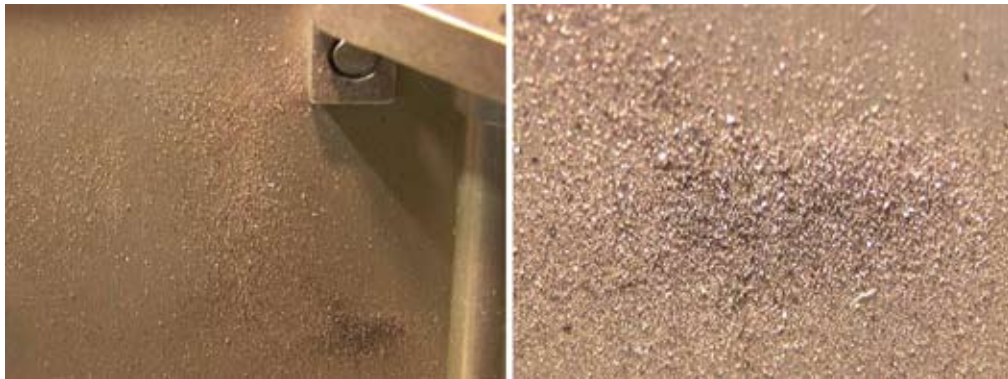
Figure 42

- 5) Four of the contactors that were examined by the aircraft manufacturer's EQA lab were found to have debris deposits on the inside of the contactor cover (see example in Figure 42). The debris was analysed and was consistent with silver cadmium oxide, and was therefore probably arc debris.

Debris (probably arc debris) on the inside of the contactor cover of an RBTB
– this is adjacent to one of the main contacts

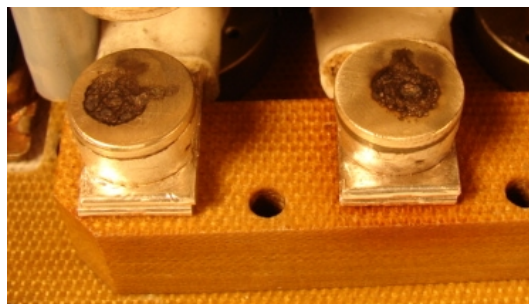
Figure 44

Example of normal contact wear (APB which has completed 25,000 flying hours and 22,000 flight cycles)

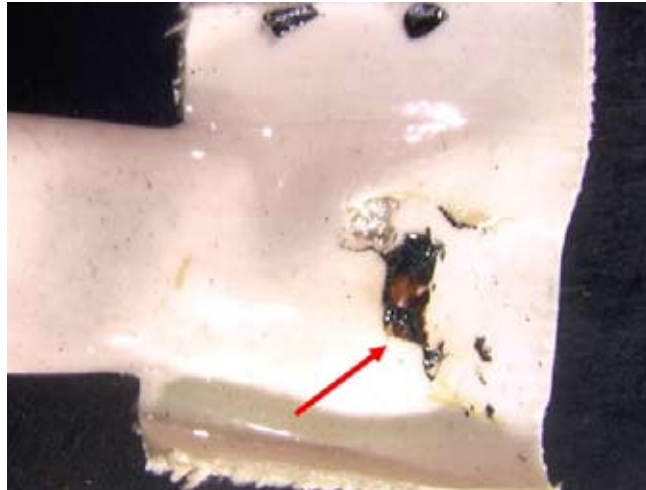
Figure 45

- 9) One of the contactors had heat damage to its silicone insulation sleeve. This occurred in one of the APBs that had evidence of over-heating. One of the silicone insulation sleeves covering the B phase pigtail had started to burn – see Figure 45. This contactor also had white deposit material on the inside of the cover case which was determined to be a mixture of silicone oil and methacryamide aromatic acid. The silicone oil was probably from the burnt silicone sleeve but the source of the acid was not determined.
- 10) One contactor was found to have a movable contact that was rubbing against the edge of the arc chute, leaving silver rub marks on it.

Burnt silicone insulation sleeve covering silver pigtail foil at B phase junction

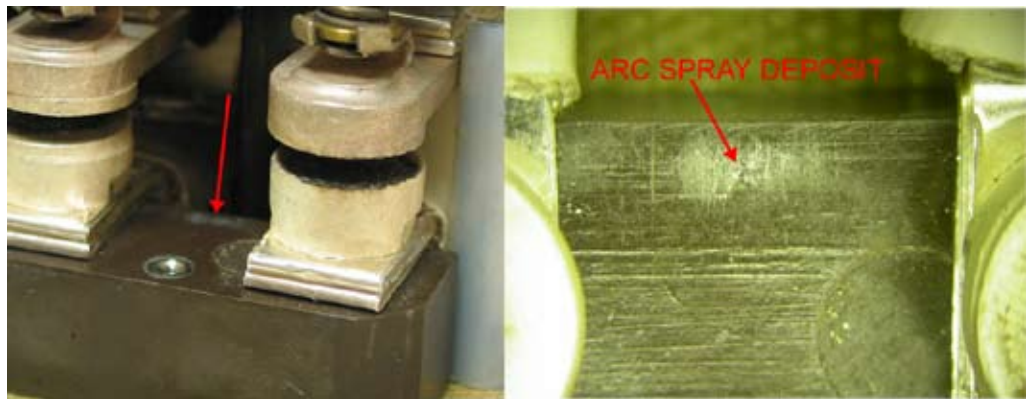
Figure 46

ERA also noticed that there was some contamination on the main contact support block between main contact phase A and B, which had the appearance of arc spray deposits. This was on the top surface of the contact support block in an area that was not covered by the arc chute – see Figure 46. The arc chute prevents arc spray from being deposited on most of the space between contacts but leaves 2 mm at the edge of each contact within line of sight of each other, and this is where the deposited material had occurred. The arc spray deposit was analysed using SEM/EDX which revealed that its composition was variable, but its major constituent was aluminium alloy and only a minor constituent was silver cadmium.

Arc spray deposit on main contact support block indicated by red arrow (left); close-up of arc spray deposit (right)

spray deposits containing aluminium on the stationary contact support block between phase A and B (see Figure 46, page 61). This was along the 2 mm edge of the support block that was not protected by the arc chute. If deposits such as these built up sufficiently to bridge the gap between the phases, a short circuit would occur. This would most likely result in the deposits vaporising in an arc flash, resulting in the open circuit being restored. However, ERA argued that if there was sufficient heat in the melamine support block (or Ryton in some contactors), the arc flash could cause the melamine to char and become electrically conductive, ie dielectric breakdown would occur and result in arc tracking through the carbon in the material. This is a phenomenon that has been observed before in printed circuit boards. The contactor manufacturer considered this scenario very unlikely and commented that it was very unlikely that arc spray would land in a continuous path across the flat surface of the contact support block not covered by the arc chute.

A planned modification for contactors built towards the end of 2008 is to change the dimensions of the arc chute. The new arc chute is significantly taller and deeper (see Figure 52, page 77) and will completely cover the stationary contact support block, preventing arc spray deposits from forming in the first place. It will also serve as a significantly more robust insulating barrier between main contact phases, that will reduce the likelihood of phase-to-phase arcing following any internal failure event (reference item 11 from safety action section 1.18.4.4, page 76).

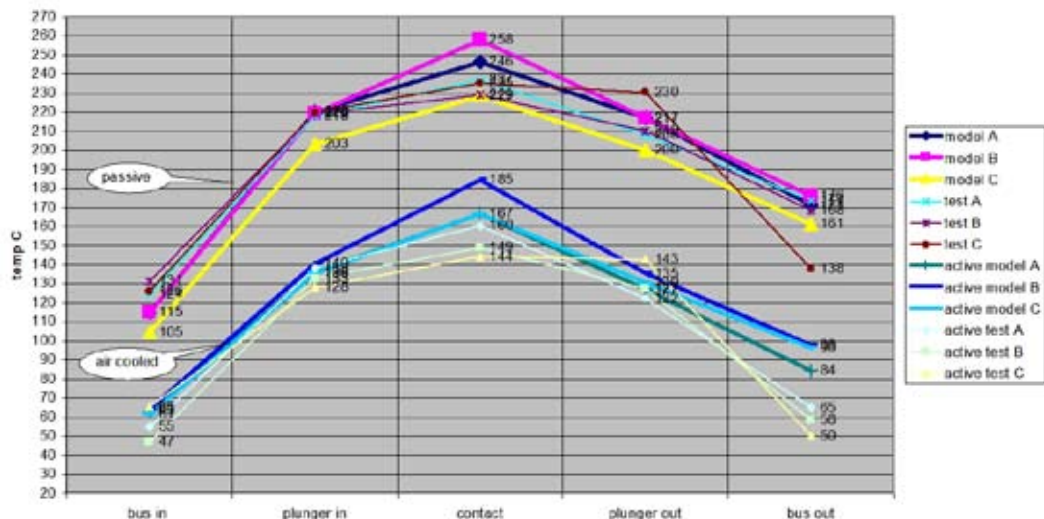
Figure 48

Temperature comparison between active and passive panel cooling for different locations within the panel. Ambient temperature was 20°C. Results also show difference between test results and thermal modelling

which installed the same active cooling modification to the P200 and P300 panels on ELMS 1. This cooling modification redirected airflow from nearby cooling ducts directly into the rear of the power panels. Tests and modelling revealed that the cooling modification reduced internal contactor temperature by about 80°C and bus temperature by between 60° to 80°C – see Figure 48.

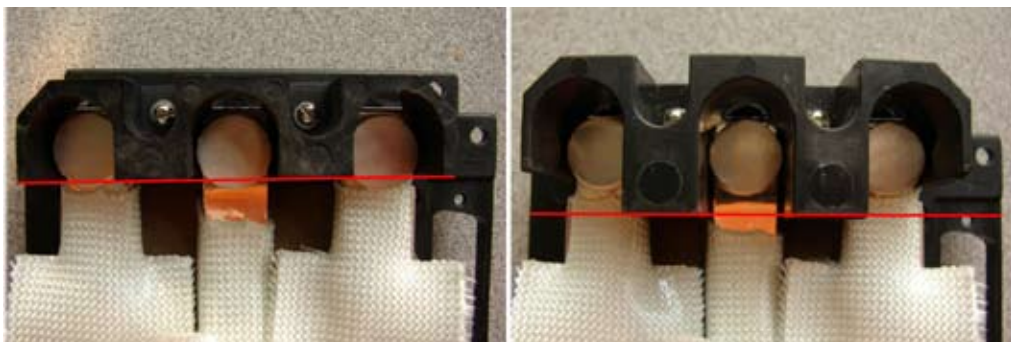
Figure 51

Top view of old arc chute (left) versus new taller and deeper arc chute (right)
– the red lines highlight the difference in size of the protected area

- 11) Planned modification for end of 2008⁴⁴: The geometry and material of the arc chute will be changed. The material will be changed from Ryton (a thermoplastic) to Dielectrite (a thermoset) which will not melt at high temperatures and has improved resistance to dielectric breakdown. The geometry of the arc chute will also be changed to make it taller and deeper to reduce the risk of a short-circuit between main contact phases and reduce the risk of a short-circuit between main contacts arcing across and destroying the contactor cover. The dimensional changes to the arc chute can be seen in Figures 51 and 52.

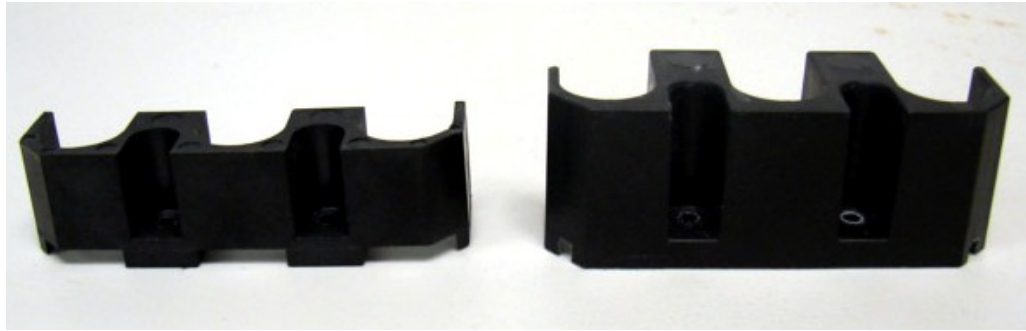
Figure 52

Front view of old arc chute (left) versus new taller and deeper arc chute (right)
– note increased protection at the base of the new arc chute

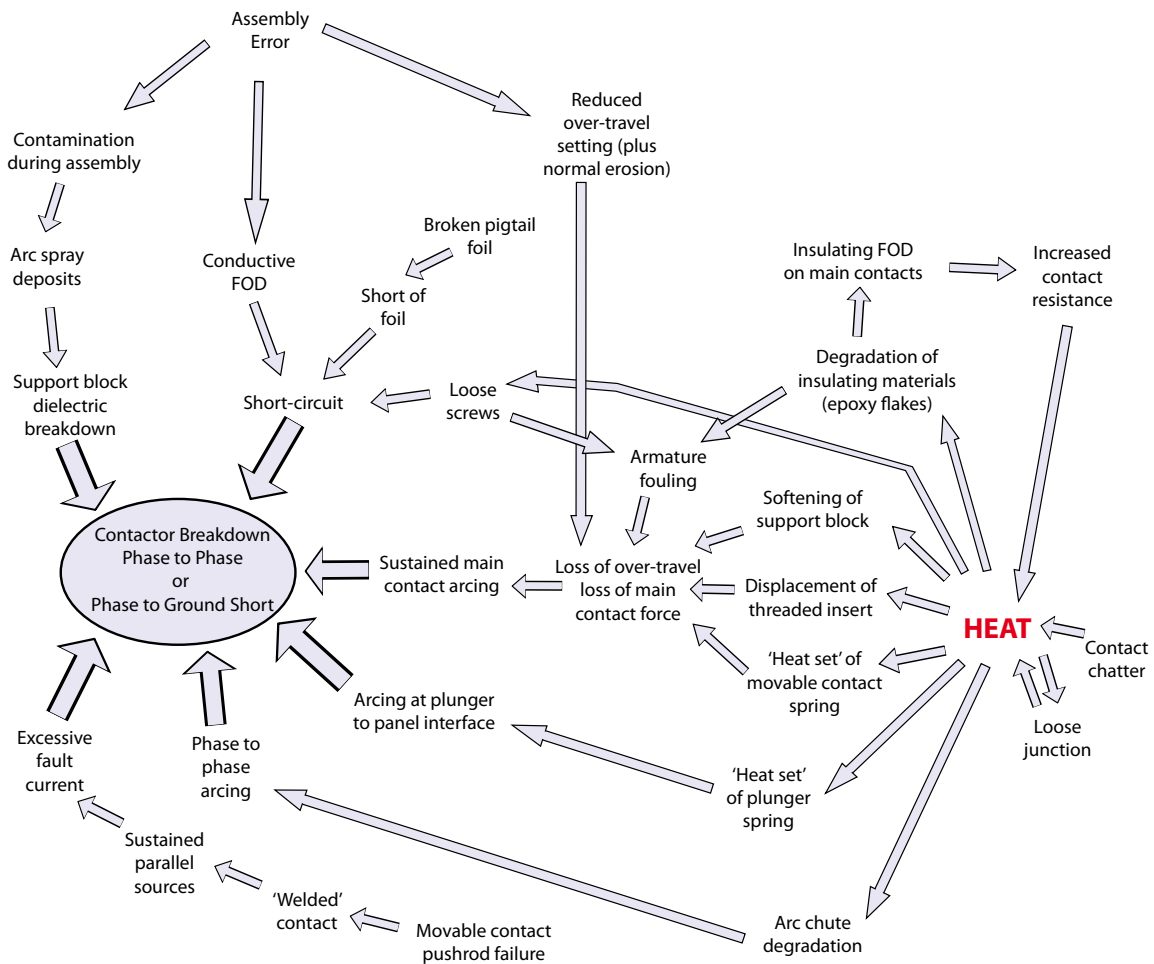
A number of possible causes of contactor failure have been considered, but there was insufficient evidence to select a most probable cause of failure. The diagram in Figure 53 summarises all the possible causes considered. Nevertheless, the most likely causes were: i) a debris induced short-circuit or debris induced fouling of the armature or ii) a loss of over-travel due to a combination of heat build-up, erosion and possibly assembly errors. A third possibility was arc tracking across the unprotected region of the stationary contact support block.

Diagram listing possible causes of contactor failure
